Engineering & Public Works Department

DATE: September 13, 2017

SUBJECT: Maier Drive Forcemain Repair Transfer Request

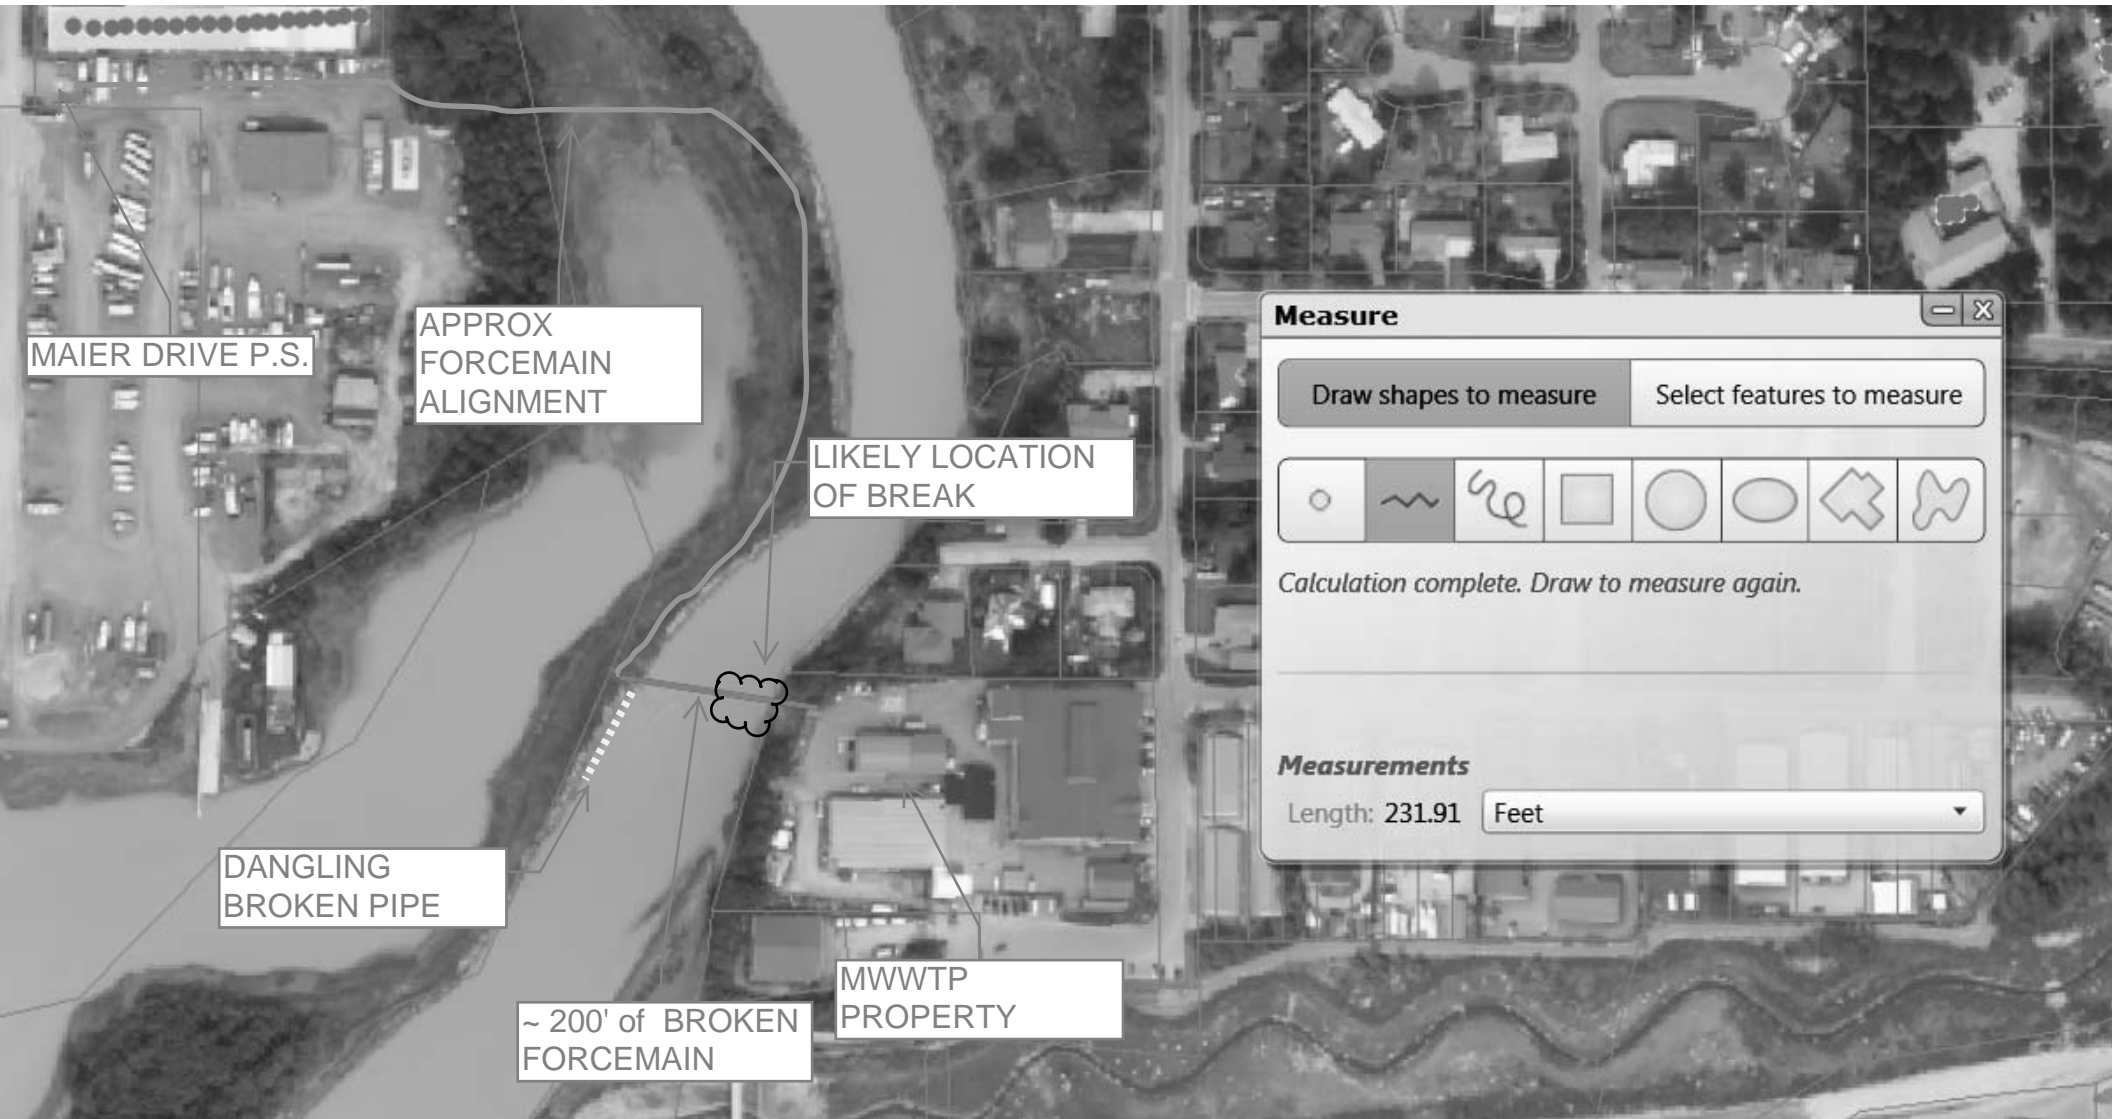
The Maier Drive Forcemain conveys wastewater from the west side of the Mendenhall River (Industrial Boulevard area, Pederson Hill, Wildmeadow etc.) to the Mendenhall Waste Water Treatment Plant (MWWTP). The forcemain across the Mendenhall River to the MWWTP broke on Saturday, September 2 due to high flows. This pipe was installed in 2007, 3' below the river bottom. The forcemain had been recently exposed and undermined by flooding and significant down-cutting of the river caused by the Jökulhlaups from the Mendenhall Glacier over the past 6 years. Fortunately, the break was caught immediately by Wastewater staff with minimal wastewater release (if any) occurring into the Mendenhall River. As an interim measure to maintain service to the area, Wastewater staff are currently trucking wastewater from the Maier Drive Pump Station to the MWWTP, an activity that is labor intensive, but doesn't impact the users.

APPROX
FORCEMAIN
ALIGNMENT

LIKELY LOCATION
OF BREAK

DANGLING
BROKEN PIPE

~ 200' of BROKEN
FORCEMAIN

CBJ Risk Management Staff are currently in discussions with our insurance carrier with optimistic hopes of this repair being covered by insurance. Design work needs to begin immediately to implement a new river crossing repair as soon as possible.
